Causes and reconstruction of a landslide in lower triassic sandstone by excavation of a cut on motorway A38

Dr.-Ing. Marc Raithel

Kempfert + Partner Geotechnik, Kassel/Würzburg

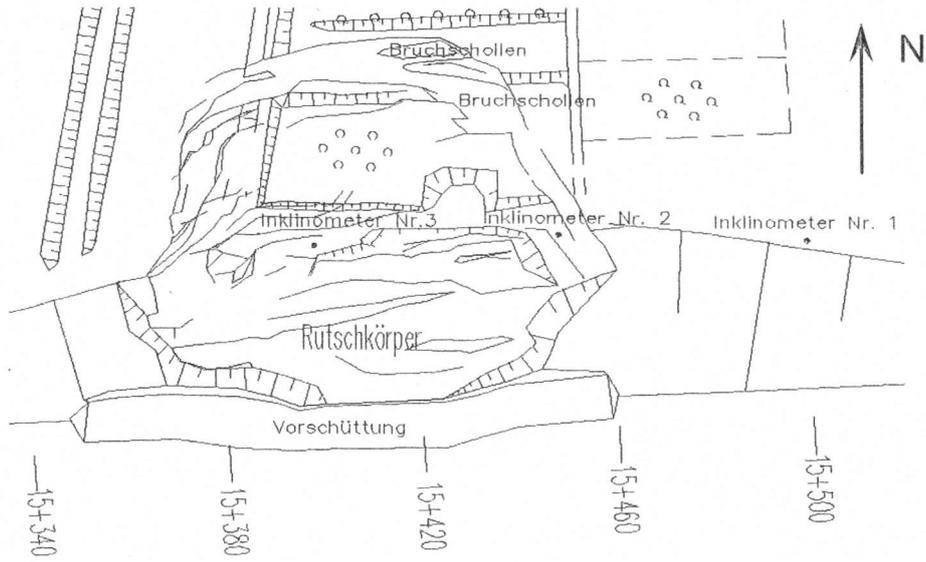
Fig. 1 „Big landslide” with fissuration in top view

The big slide-body is shown in top view in Fig. 1 with the detected fissuration. The body can be evidently described as a prismatic tetrahedron or wedge-shaped body with a synclinal floor area (Fig. 2).

In the lower area of the rock slide a hog was visible, which was up to 2 m higher than the soil surface and was stabilised in the meantime with a preload (Fig. 1) in the lower part of the slope and at the toe. In the area of the former top of the slope, multiple wide fissures and terraces were present, which basically ran parallel to the former top of the slope. A several meters high, almost vertical tear-off edge was detected behind the top of the slope, in front of a neighbouring tree population, whereby a several meters high, almost horizontal notch was accumulated in front of the tear-off edge (Fig. 3). With a distance of about 40 to 45 m to the original top of the slope, in the neighbouring tree population, a mighty fissure with a width of more than 5 m and several different clods of earth was found. The rear limit consisted of a vertical tear-off edge with a height of more than 4 m (Fig. 4).

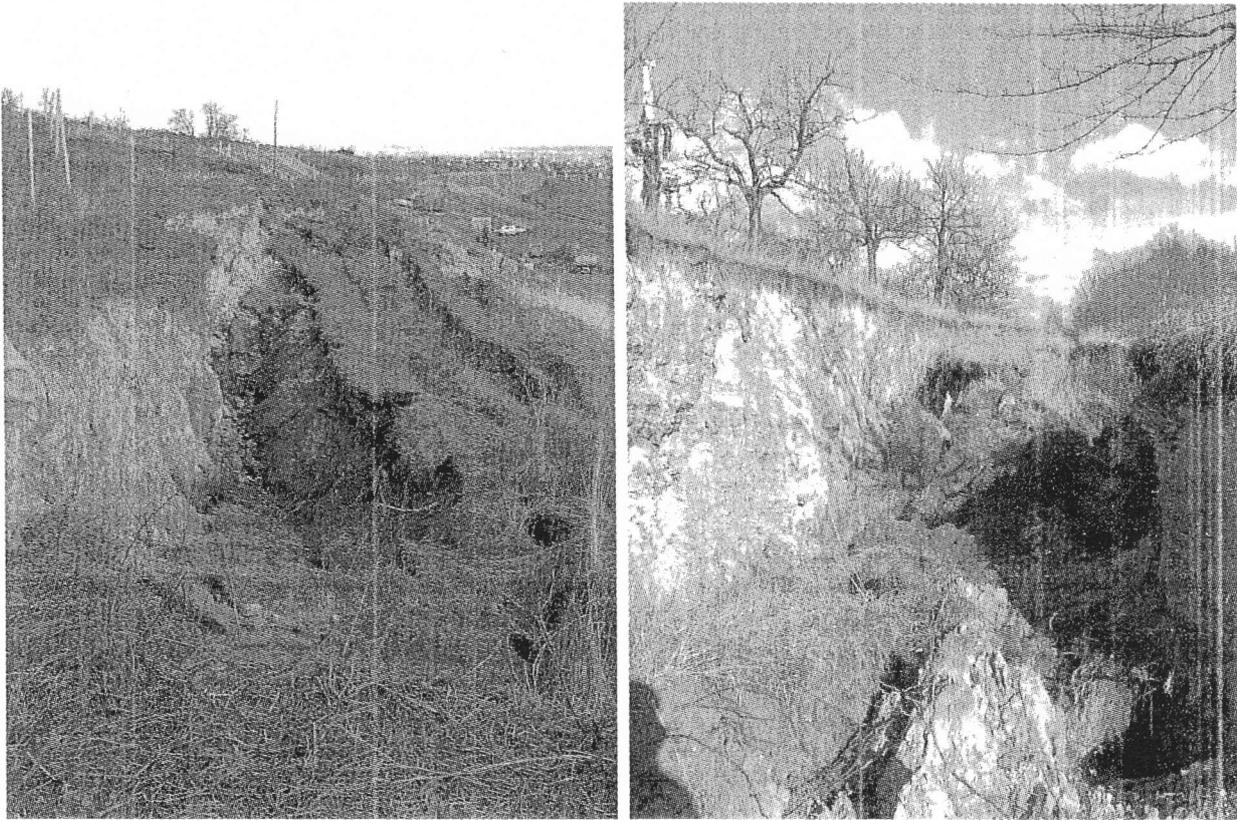
Fig. 3 (left) Area of the former top of the slope

Fig. 4 (right) Rear tear-off edge of the slide-body, about 40 to 45 m behind the former top of the slope

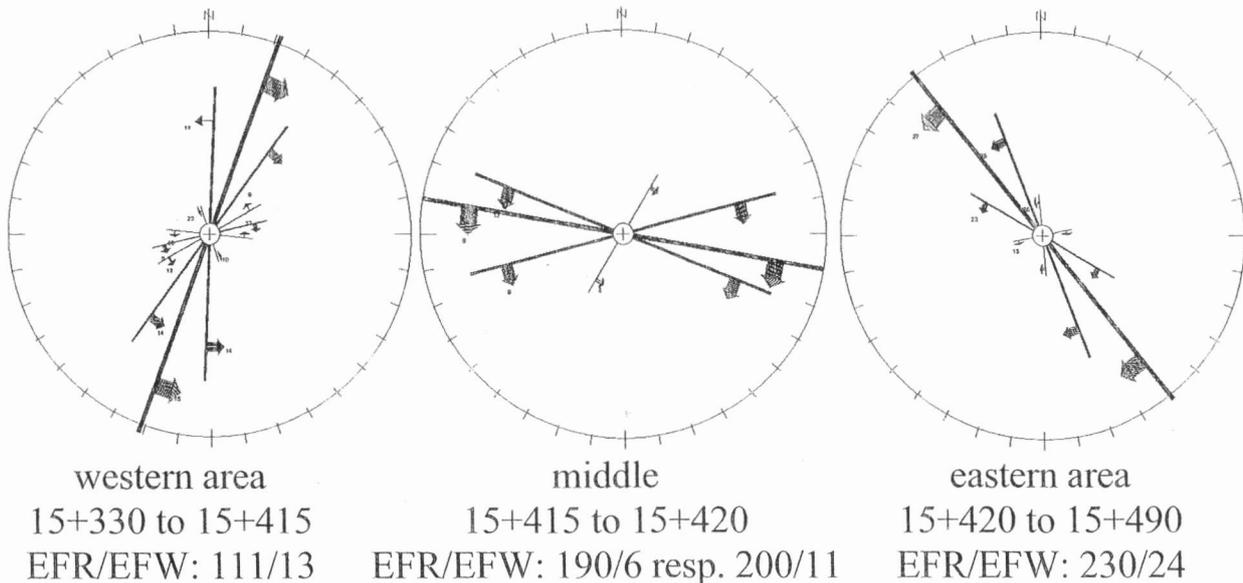
Fig. 5 Lagekugeldarstellung of the strata joints (biggest frequency of occurrence) direction of incidence EFR; angle of incidence EFW

The geological model could be completed using the inspection of the landslide on the surface of the slope and the geological survey of the close-to-surface areas of the tear-off edge and the measurements on the surface of the slope during the excavation of the cut. The course of the strata joints in the area of the slide-body results from the evidently wedge shaped resp. synclinal run, whereas strata joints could be detected in the middle of the slide-body over a limited length, which are even heading in nearly southern direction and as consequences at right angle to the trace of the motorway, which show an angle of incidence of approximately 10° (Fig. 5).

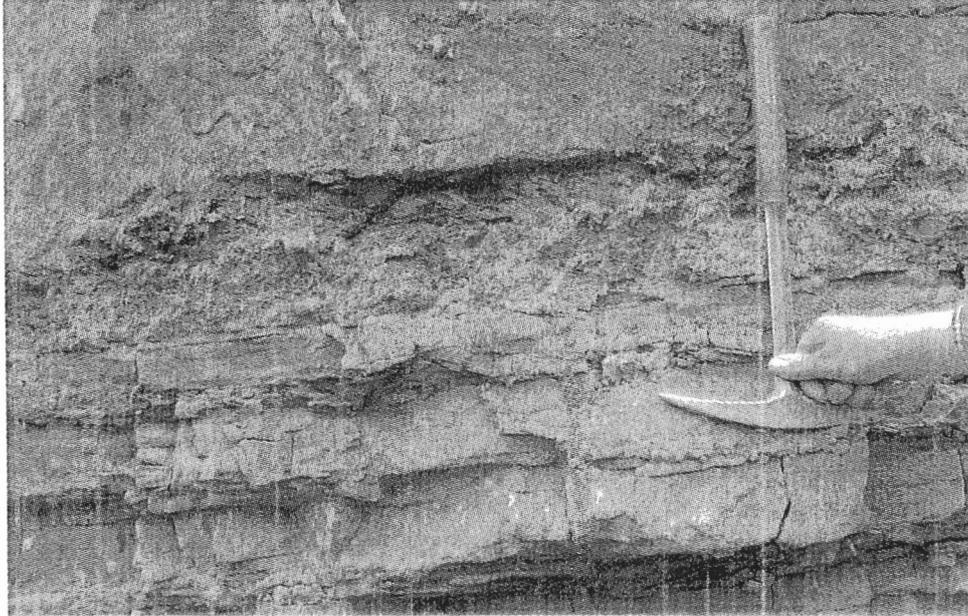
During the geological survey and the inspection of the front and rear tear-off edge of the slide, it was detected in particular, that strata joints filled with clay / silt and a thickness of several centimetres were present in the clay-, silt- and sandstone-layers resp. - stratums and in parts between these layers and the calcareous sandstone (see Fig. 6).

Fig. 6 Slip joint in trial hole number 6

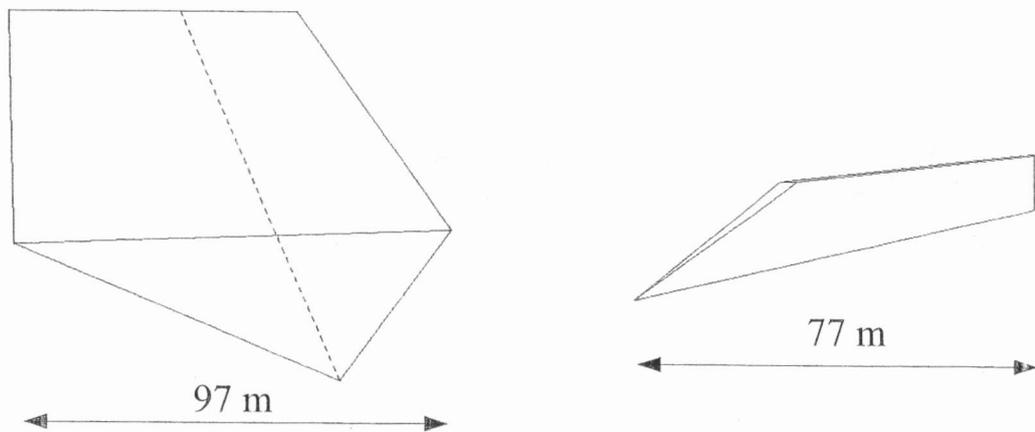
Fig. 7 Three dimensional body (schematically)

model	bedding plane direction of incidence/angle of incidence [°]	angle of friction φ_{ss} [°]	stability η [-]
plane body	190/6 (middle)	20 10	3,5 1,7 ¹⁾
	200/11 (middle)	20 10	1,9 1,0 ¹⁾
	230/24 (east)	20 10	0,8 0,7 ¹⁾
	111/13 (west)	20 10	1,6 0,8 ²⁾
three dimensional body (Fig. 7)	111/13 (west) und 224/24 (east)	20 10	2,3 1,1 ¹⁾

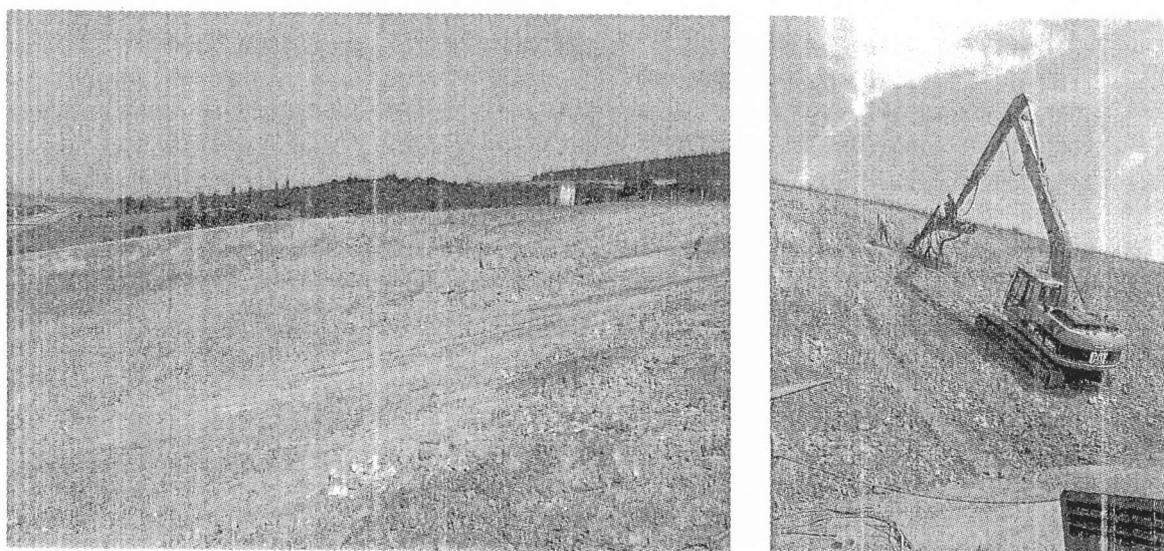
Fig. 8 Reconstruction a) flattened slope b) bolting

The fundamental plan for the reconstruction of the big slide was to flatten the slope till the slip plane, because the sufficient surface was available. The sled material in the central area of the synclinal damage was totally cleared above the slip joint (Fig. 8), so that no extra safeguards were necessary.

An additional bolting was planned in the border area north of the former tear-off edge and in the eastern transition area with an approximately 1:3 tended slope to the normal slope. The geometry of the slope and the conception of the bolting was defined during the reconstruction, that is to say during the clearing of the rock masses on the basis of the existing cognitions concerning the depth of the slip plane, of the height of the new slope and of the additional survey of the structure of the undisturbed Lower Triassic Sandstone. About 500 bolts (system GEWI) with a length between 6 and 12 m were installed in the area of the big slide in a grid space from 1.5 to 2.5 m (Fig. 8).
