CAUSES AND RECONSTRUCTION OF A LANDSLIDE IN LOWER TRIASSIC SANDSTONE BY EXCAVATION OF A CUT ON MOTORWAY A38 (GERMANY)

Dr.-Ing. M. Raithel¹ & Dipl.-Ing. A. Kirchner²

^{1,2} *Kempfert + Partner Geotechnik, Würzburg/Kassel, Germany*
(e-mail: wue@kup-geotechnik.de)

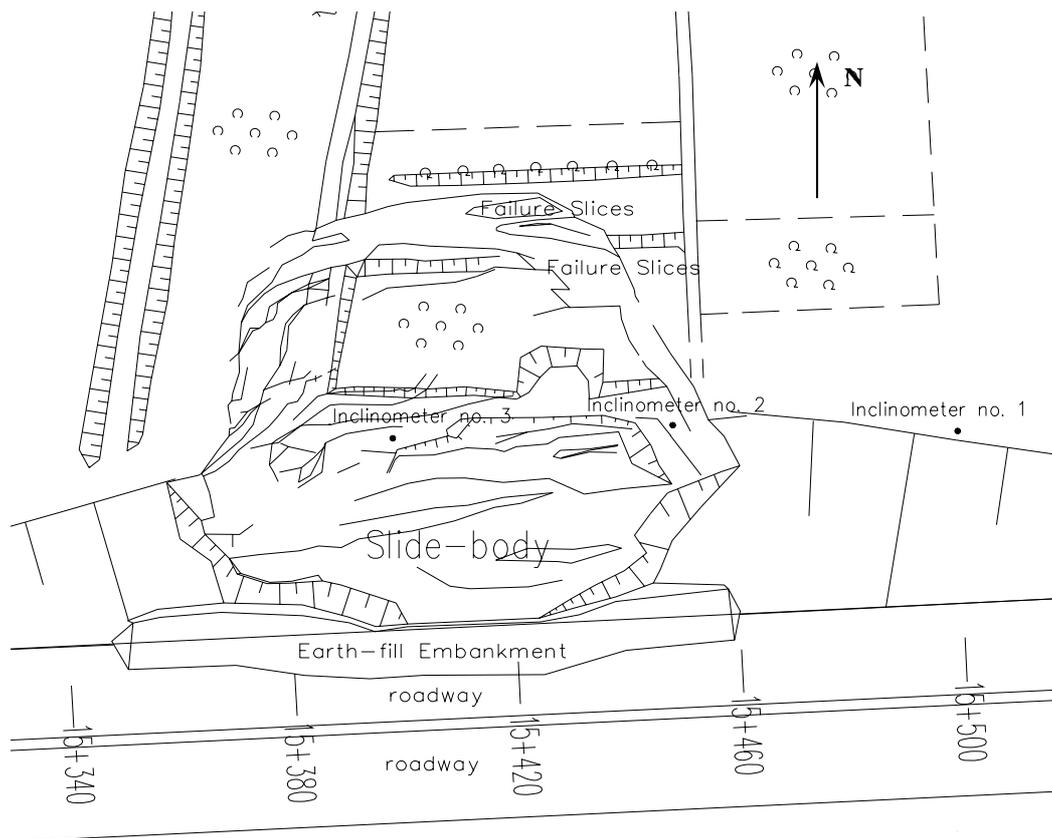
A top view of the main slide body with the detected fissuration is shown in figure 1. The viewable slide body can be described as a prismatic tetrahedron or wedge-shaped body with a synclinal floor area (figure 2).

Figure 1. Major landslide with fissuration

In the lower parts of the slope rock soil and rock masses bulged up to 2 m higher than the former ground surface. As an immediate measure a temporary embankment was built on the lower parts and at the toe of the slope to stabilize the bulge (figure 1). In the area of the former slope top numerous wide fissures and terraces were visible. Most of them basically ran parallel to the former top of the slope. Behind the top of the slope next to an adjacent tree population there was an almost vertical tear-off edge with a height of several meters. In front of the tear-off edge a displacement of several meters had emerged (figure 3). In a distance of about 40 to 45 m to the original top of the slope amidst the adjacent tree population an enormous fissure with a width of more than 5 m and several clods and slices of earth were detected. The rear boundary of the slide body consisted of a vertical tear-off edge with a height of more than 4 m (figure 4).

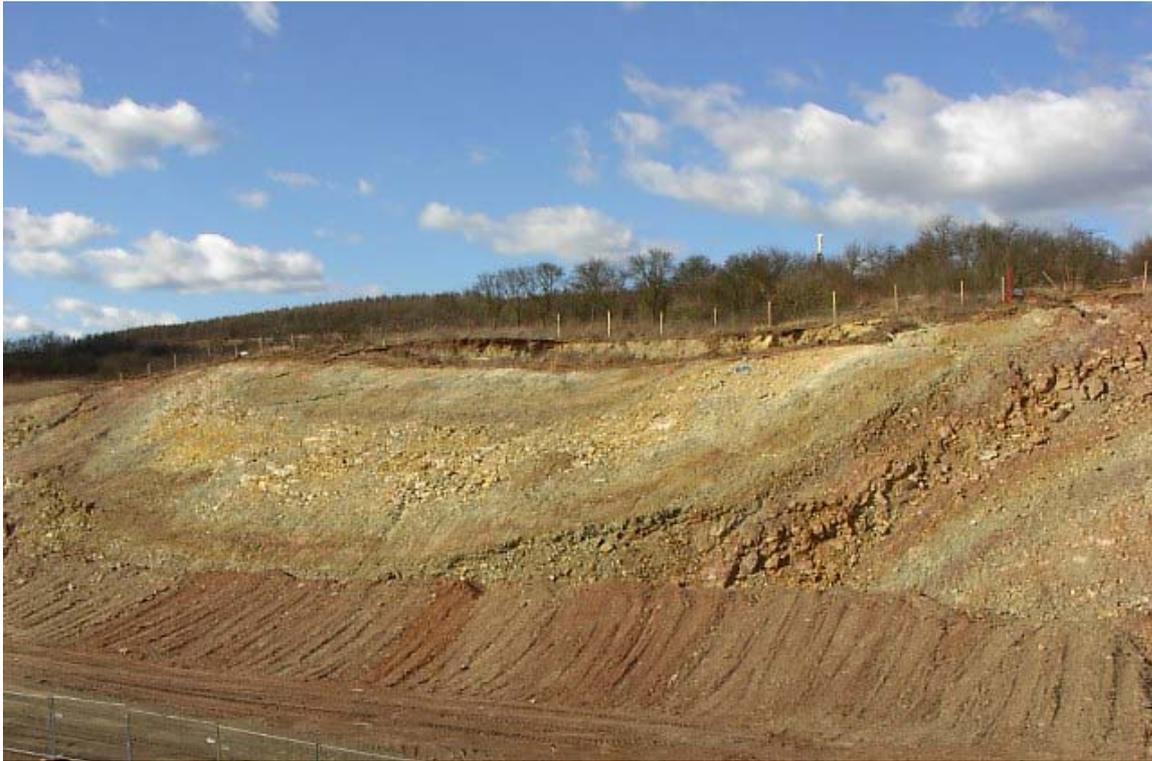
Figure 2. Overview of the major landslide

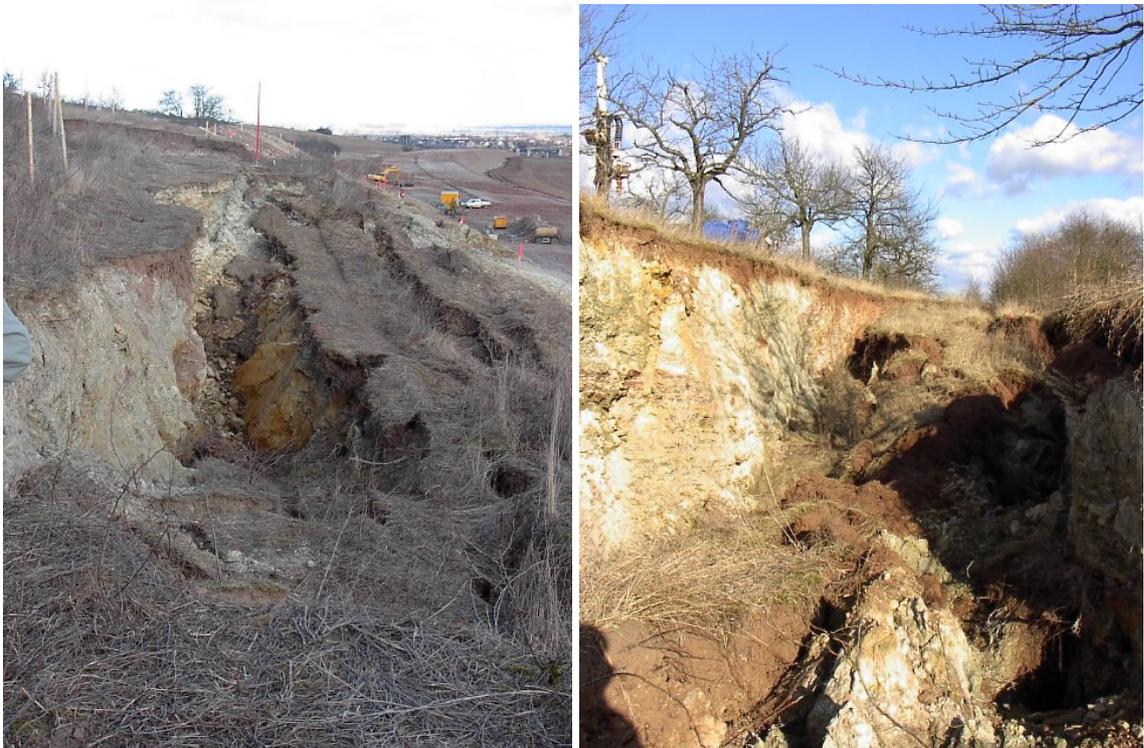
Figure 3 (left). Area of the former top of the slope
Figure 4 (right). Rear tear-off edge of the slide body about 40 to 45 m behind the former top of the slope

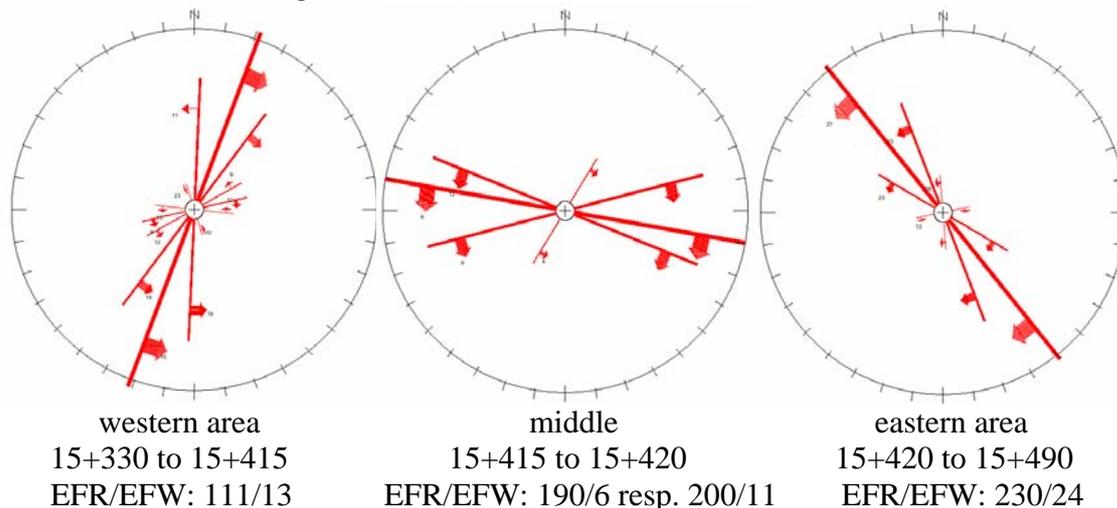
Figure 5. Graphs of the strata joints (highest statistical frequency); direction of dip EFR, dip angle EFW

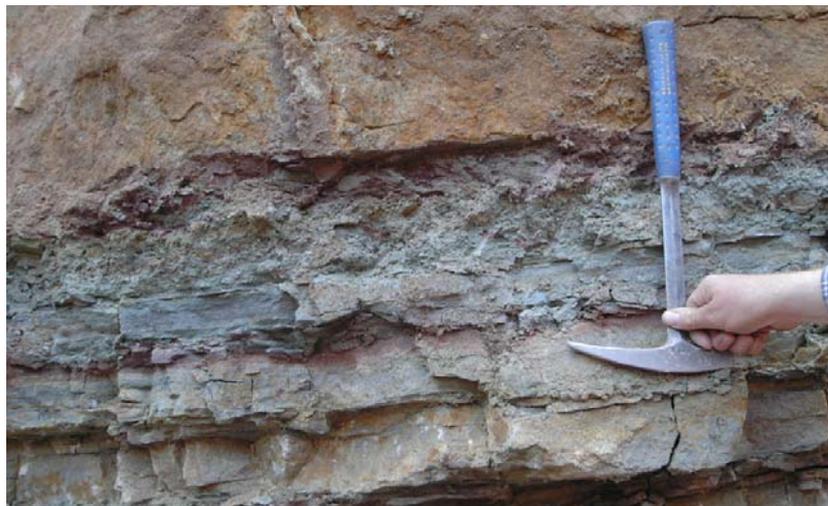
The geological model could be completed by observations made during the geological survey of the surface and tear-off edge of the slide body of in the course of the removal of the slid material. The geological survey revealed that the course of the strata joints in the area of the slide body followed the apparently synclinal run. Over a limited length in the centre of the slide body the strata joints were bending almost perpendicularly towards the motorway, in an angle of incidence of about 10° (figure 6 and 7).

mainly situated between clay-, silt- or sandstone-layers and the calcareous sandstone (see figure 6). Disturbed samples were taken from these bigger strata joints in order to carry out classification tests. According to the classification the samples consist of plastic clay and silt. Additionally two independent institutes conducted a mineralogical analysis of the clay. In these analyses it was found that the soil consists of swellable intra-crystalline clay minerals (Illite and Smectite: 17 – 20 percent by weight in total, i.e. 40 – 43 percent by weight of the clay fraction with $d < 2 \mu\text{m}$). Due to this high percentage of swellable clay minerals a significant influence of the soil-physical properties on the failure was assumed.

Figure 6. Cross section with sliding zone

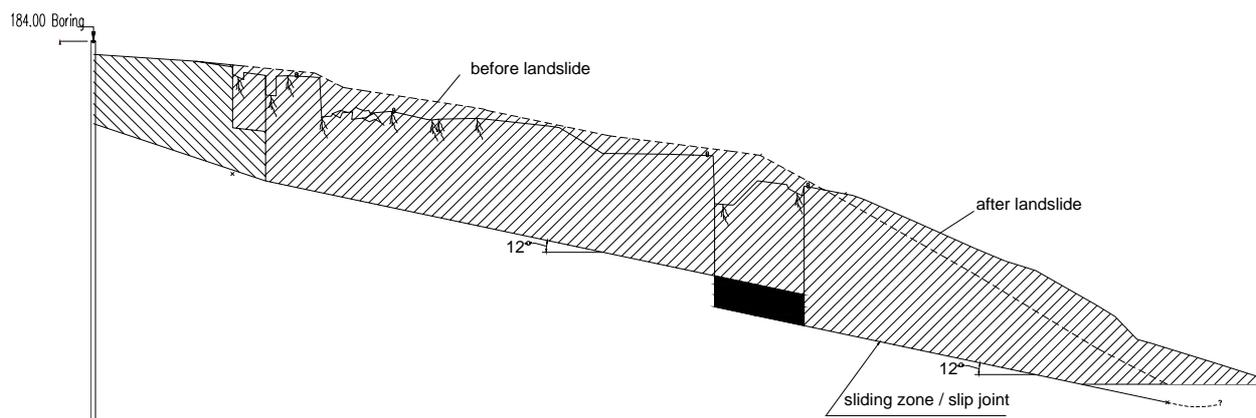
Figure 7. Slip joint in trial hole No. 6

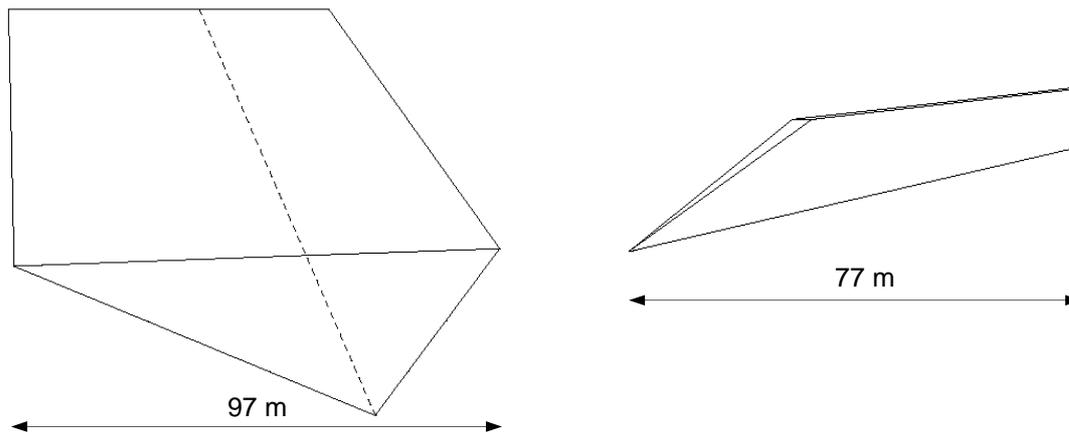
After defining the main strata joints and evaluating the geotechnical survey statistically, several simplified geotechnical models were analysed by the program SOLIDROCK (HarbourDom, Cologne). This program calculates the stability according to Kovari & Fritz 1976. Initially plane slide-bodies were tested. This examination requires that individual bodies are sliding successively. Since minor stabilities were calculated particularly in the eastern area, first of all the eastern and middle part should have slid followed by the western part because of the lacking lateral support. This examination is not adequate to analyse the failure as at the beginning of the slide a certain blocking between the bodies can be premised. Higher stabilities were calculated by consideration of three-dimensional slide-bodies. A safety factor of $\eta \approx 1.1$ was determined by using a wedge shaped body (figure 8) and an assumed unfavourable angle of shear friction of $\varphi_{SS} = 10^\circ$.

Figure 8. Three dimensional body (schematically)

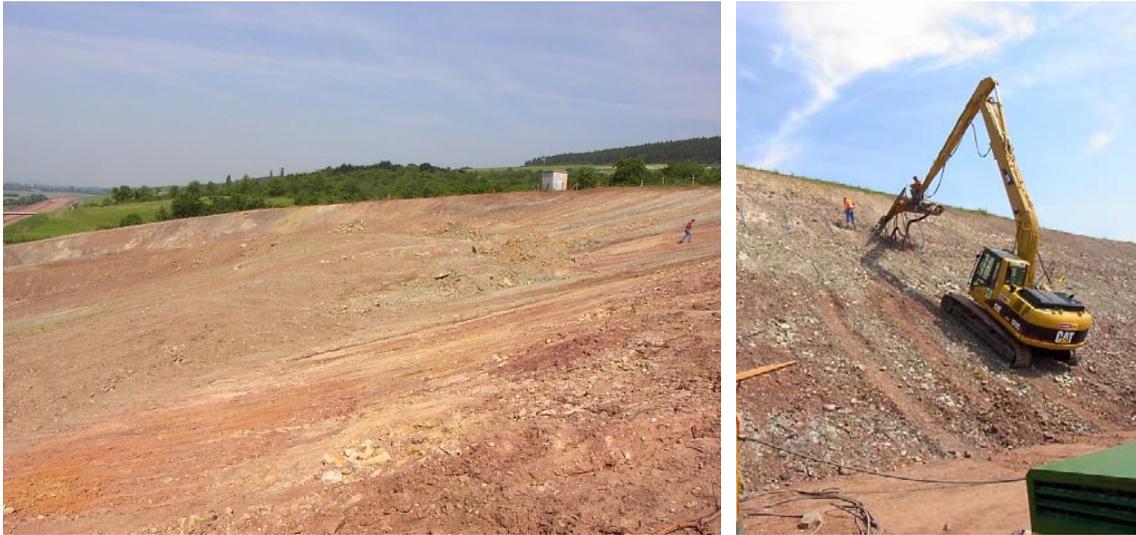
Figure 9. Reconstruction a) flattened slope b) bolting

As enough space was available the general plan was to flatten the slope down to the inclination of the slip surface. In the central area of the synclinal failure the slid material was removed completely above the slide plane (figure 9), so that no additional structural measures had to be taken.

North of the former tear-off edge and in the eastern transition area to the undamaged slope, additional bolting was planned at the new slope which was rebuilt with an inclination of 1:3. Altogether about 500 bolts (system GEWI) with a grid space from 1.5 to 2.5 m and a length between 6 and 12 m were installed in the area of the slide (figure 9).
